Inspection Report

Property Address:
123 Sample St.
Knoxville TN 37918

TnPro Residential Inspection, LLC

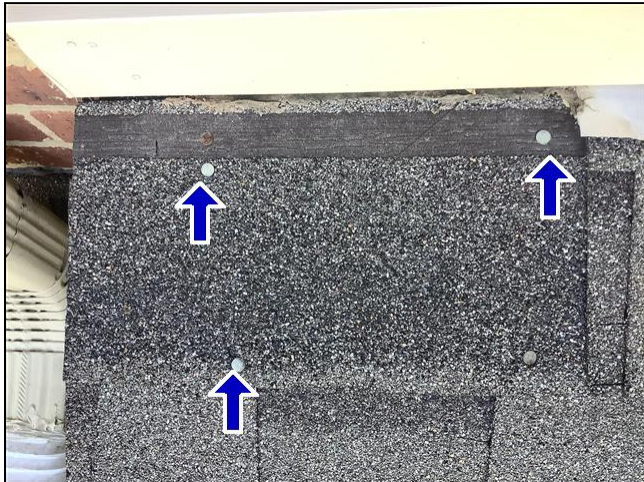
1.0 Item 2(Picture)

(2) Multiple exposed nail heads were found on the roof. All nail heads should be sealed to prevent rusting, which could lead to roof leaks. Recommend repair by a qualified tradesman.

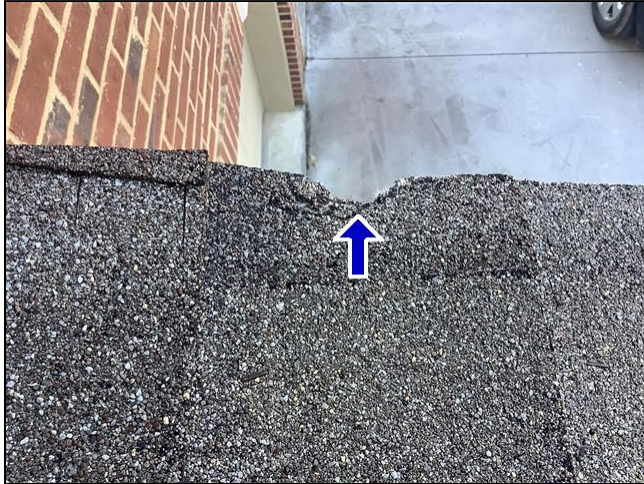
1.0 Item 7(Picture)

(3) Damage to shingles was noted in two places. These were on the edge of the roof, so the damage should not allow any leaks or damage to the structure itself.

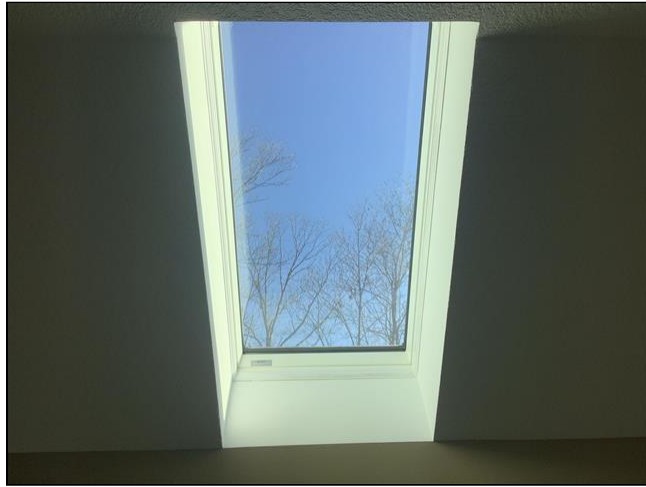
1.2 Item 1(Picture)

No defects were noted with the skylights.

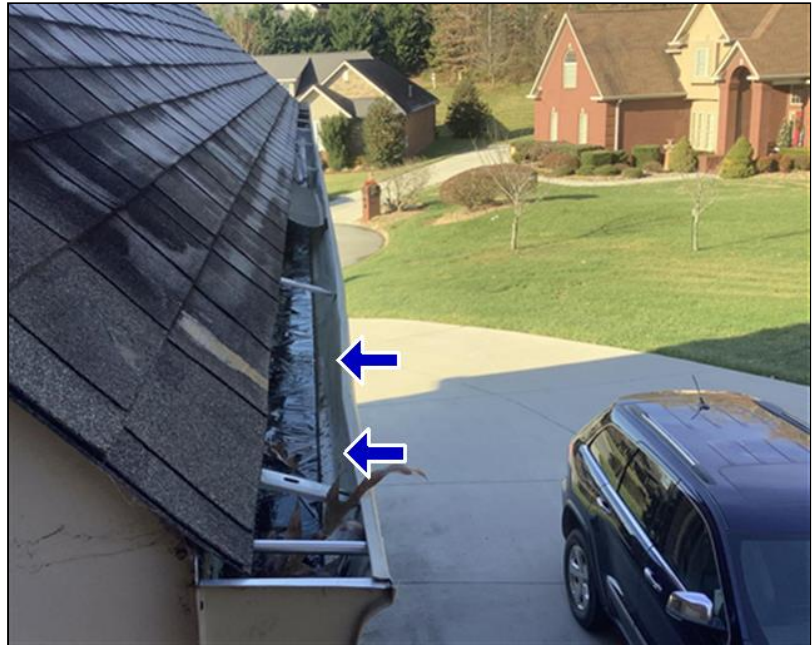
1.4 Item 1(Picture) Gutter over garage

(1) The gutter over the garage was holding water. Recommend evaluation and repair by a qualified tradesman.

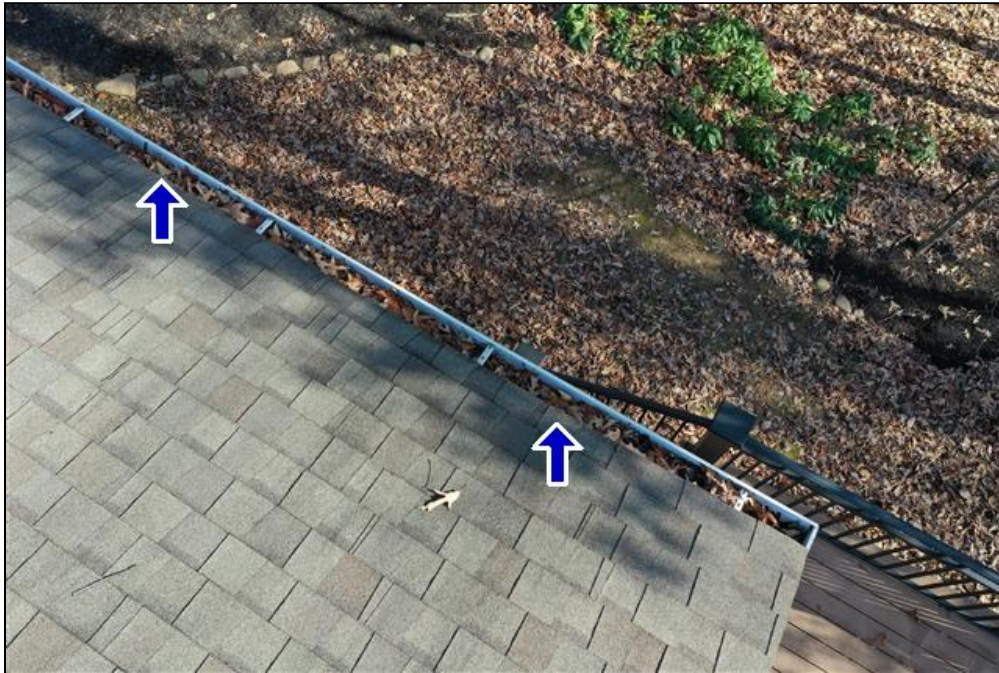
1.4 Item 2(Picture)

(2) The gutter for the sunroom was full of leaves. This can prevent water from draining properly. Recommend a full cleaning of the gutters.

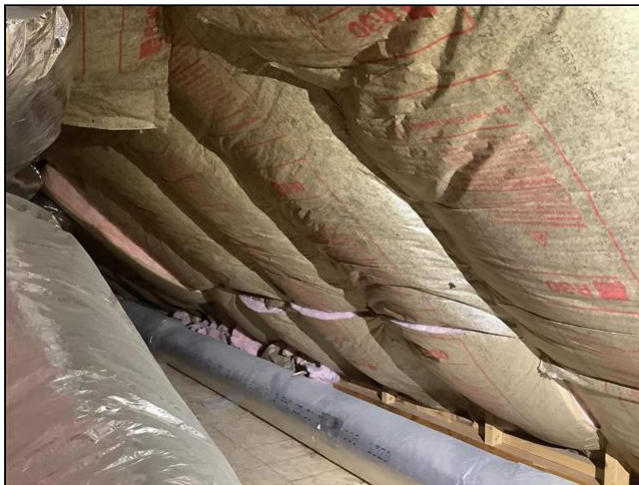
1.7 Item 1(Picture)

Insulation in the attic was installed with the vapor barrier exposed and on the interior. In Knoxville's climate, it is generally recommended that the vapor barrier be installed to the outside. Recommend further evaluation and repair by a qualified tradesman.

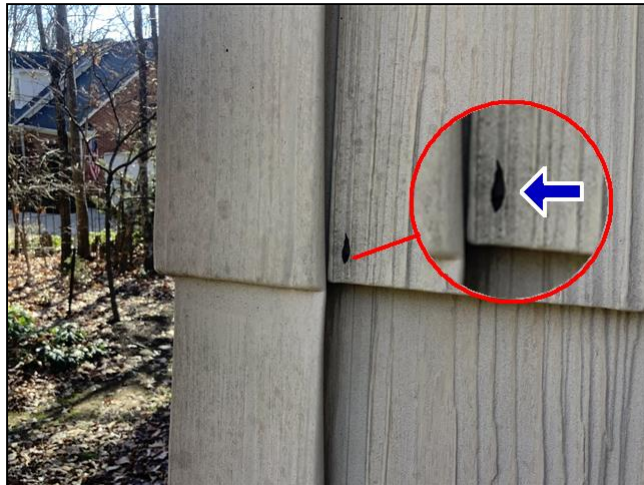
2.0 Item 1(Picture)

A penetration was noted in the vinyl siding on the sunroom. Recommend sealing to prevent water and pest intrusion.

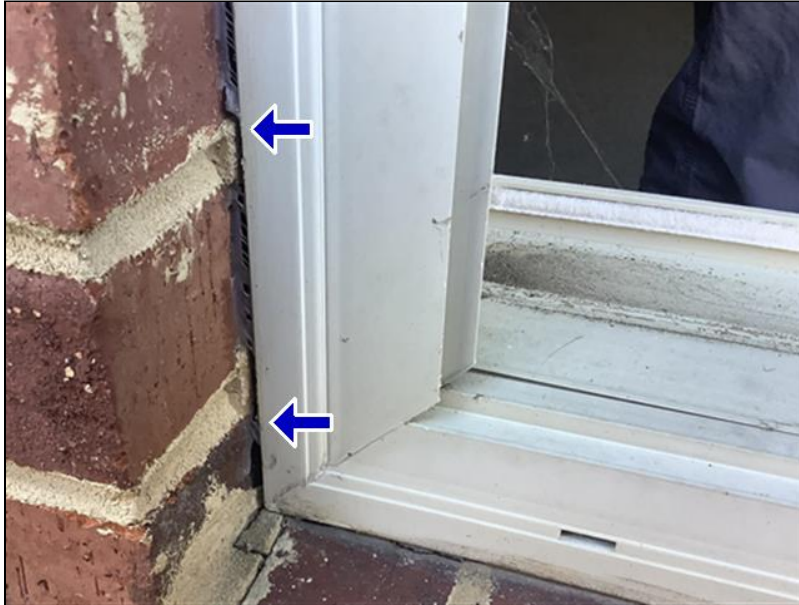
2.2 Item 1(Picture)

Gaps between windows and the brick cladding were noted at multiple windows. This is common and occurs as the installed sealant decays due to weather exposure. Recommend sealing to prevent water, air, and pest intrusion.

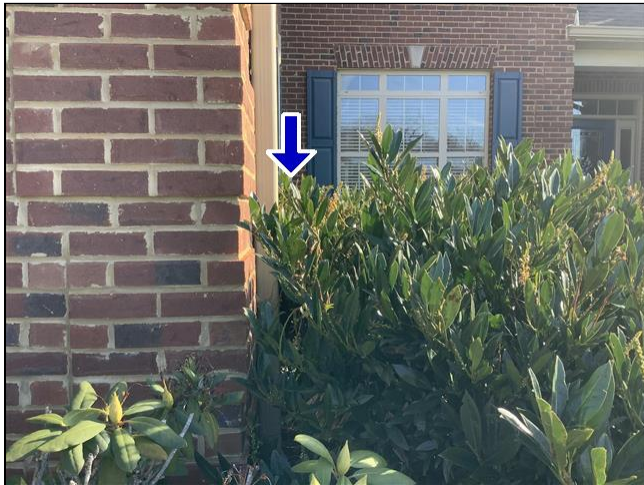
2.4 Item 1(Picture)

Vegetation was too close to the house. To prevent damage to the structure, recommend trimming all vegetation at least 12 inches away from the structure.

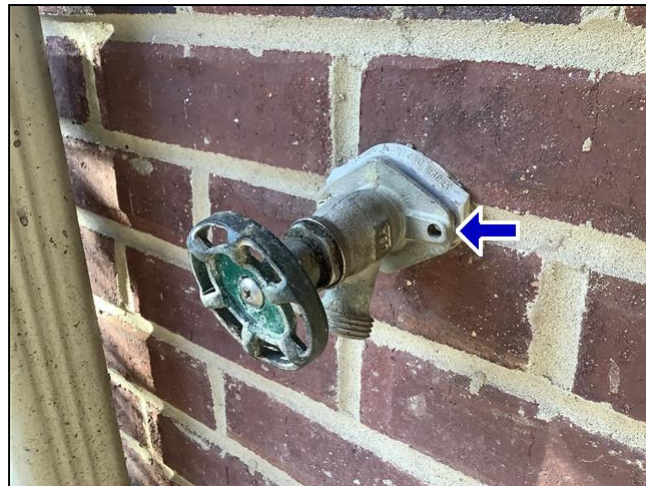
2.6 Item 1(Picture)

The hose bib was not properly attached to the structure at the time of the inspection. The bib should be fastened to the structure to prevent damage. Recommend repair.

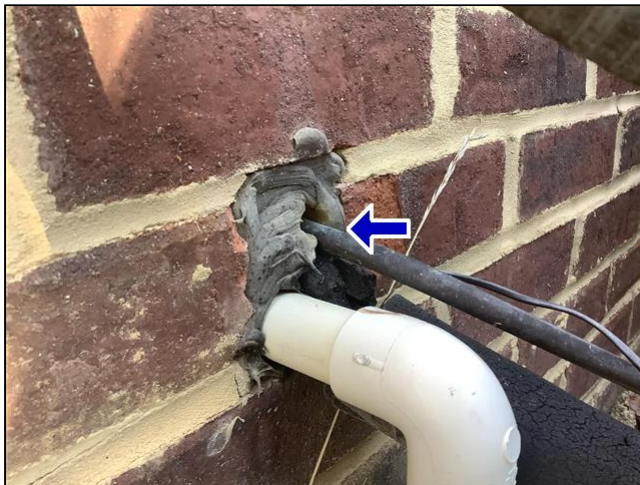
2.8 Item 1(Picture)

The penetrations for the downstairs HVAC lines were previously sealed and the sealant was decayed slightly. All exterior penetrations should be completely sealed to prevent water, air, and pest intrusion. Recommend repair.

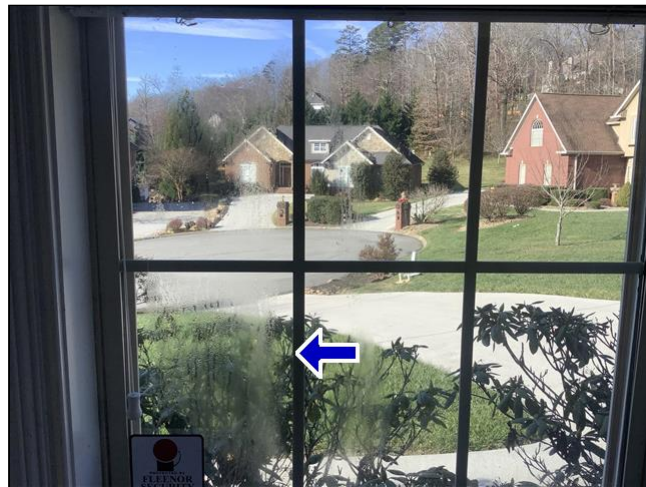
3.4 Item 1(Picture)

Moisture was observed in one of the garage windows. This is indicative of a seal failure in the window. Recommend further evaluation and repair by a qualified tradesman.

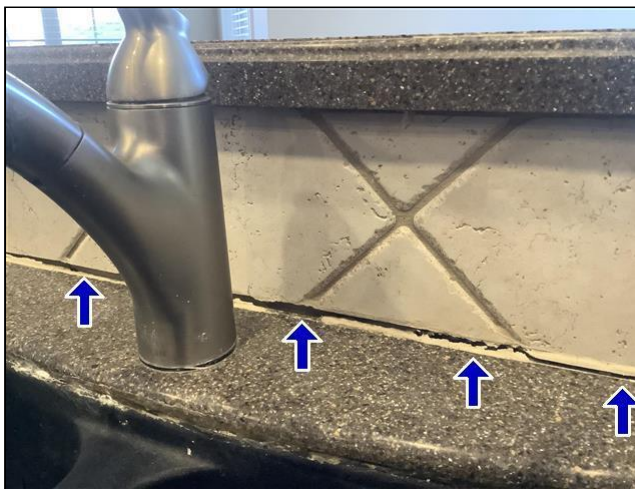
4.0 Item 1(Picture)

Gaps were noted between the countertops and adjacent walls. This can allow moisture penetration and damage. Recommend sealing.

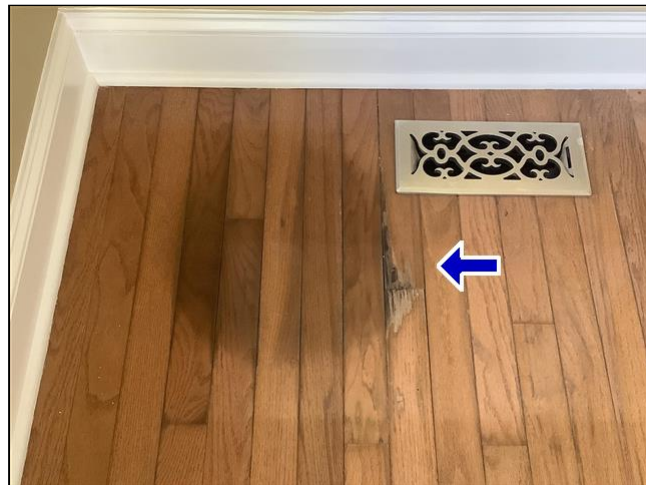
5.2 Item 1(Picture)

A water damaged area was noted on the floor near the kitchen. This was identified as a cosmetic defect and is noted for your information. Recommend repair.

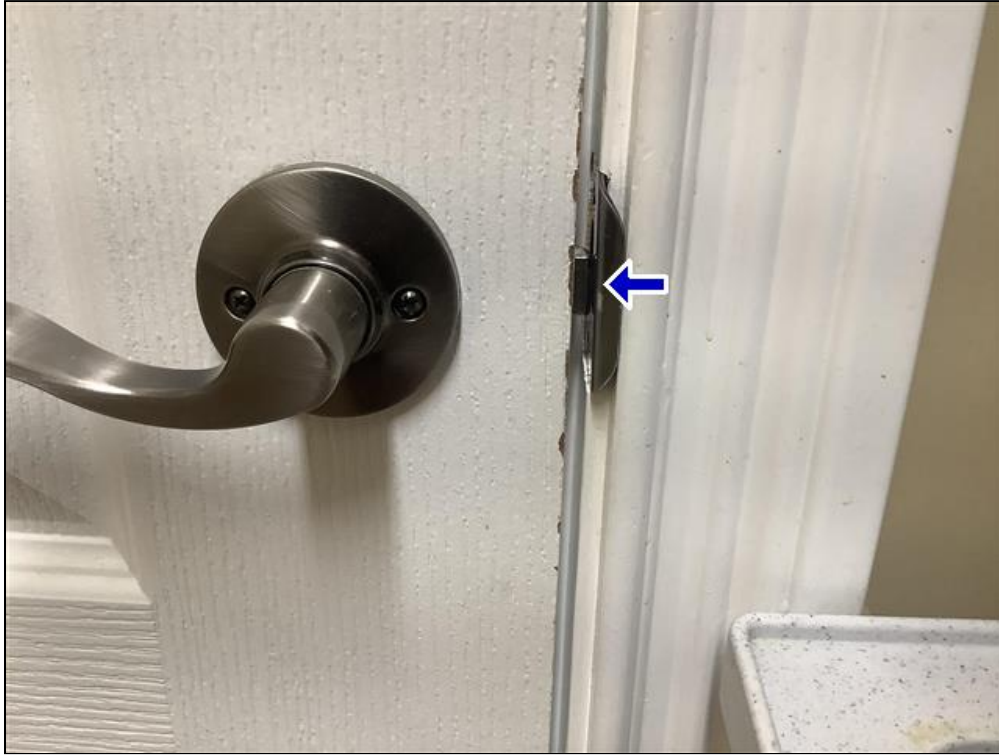
5.4 Item 1(Picture)

(1) The laundry room door did not latch when closed. Recommend further evaluation and repair by a qualified tradesman.

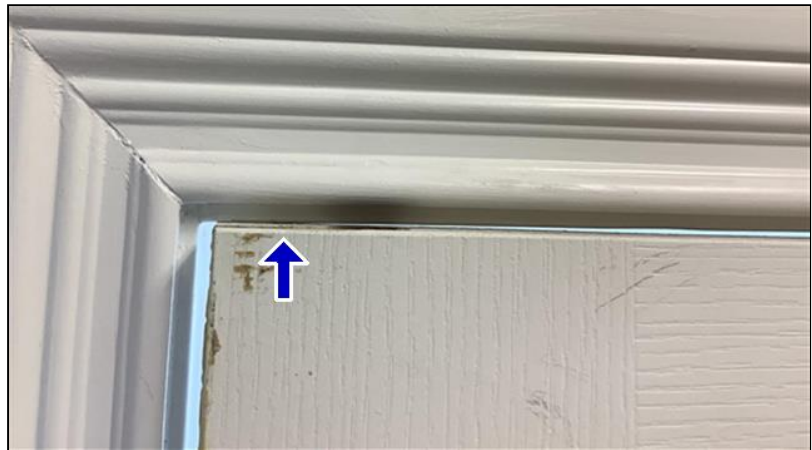
5.4 Item 2(Picture)

(2) The master closet door rubbed the door frame at the top. This did not allow the door to close completely. Recommend evaluation and repair by a qualified tradesman.

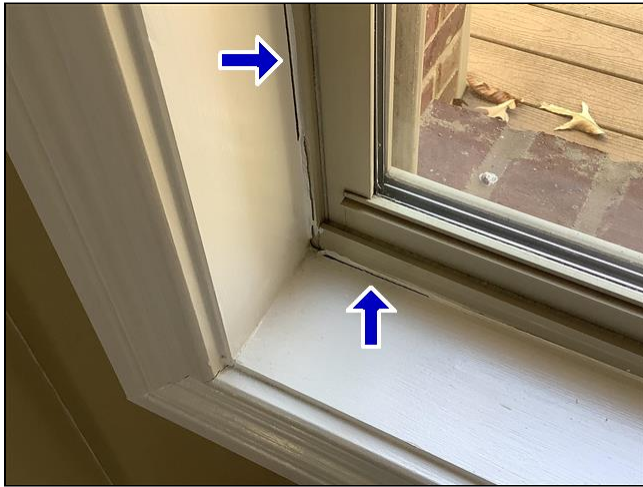
5.5 Item 1(Picture)

Multiple windows had gaps between the window sill and the window frame. This is a common occurrence and is usually caused by the expansion and contraction of the different materials (wood and vinyl). Recommend sealing all gaps around windows to prevent possible drafts.

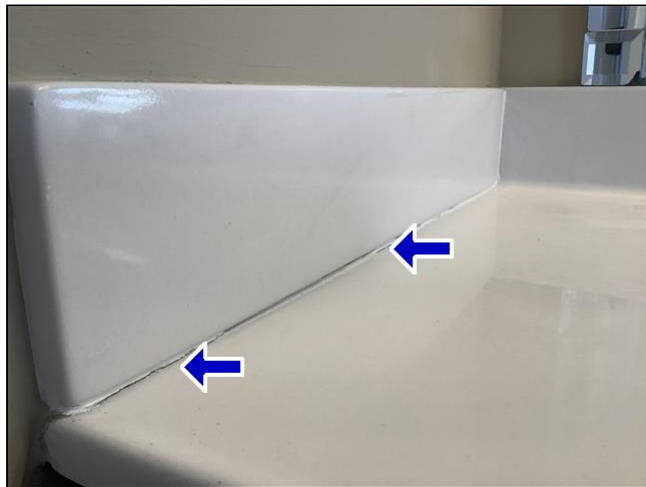
6.0 Item 1(Picture)

Gaps and cracks were noted around bathroom vanities. All gaps and cracks around sinks and other open water sources should be sealed to prevent water damage. Recommend sealing.

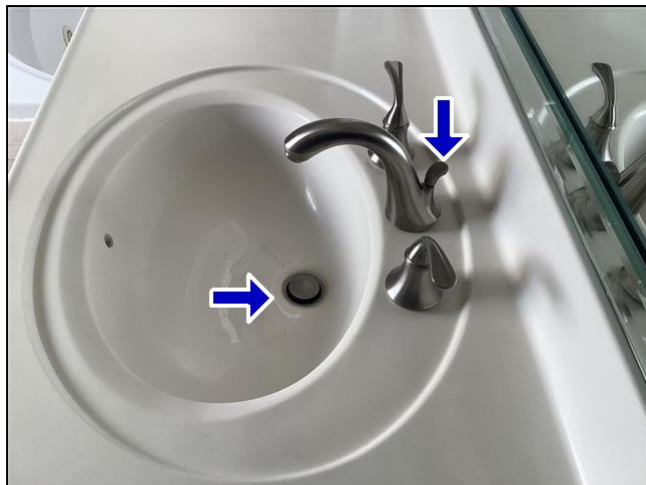
6.3 Item 1(Picture)

The right sink in the master bathroom did not have an operable drain stopper. Recommend further evaluation and repair by a qualified tradesman.

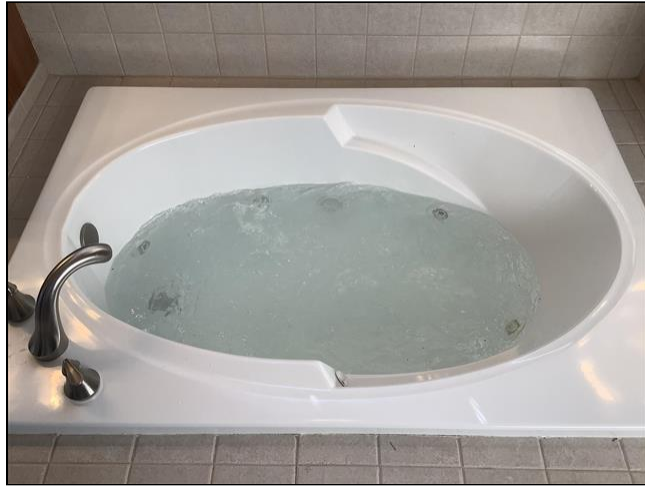
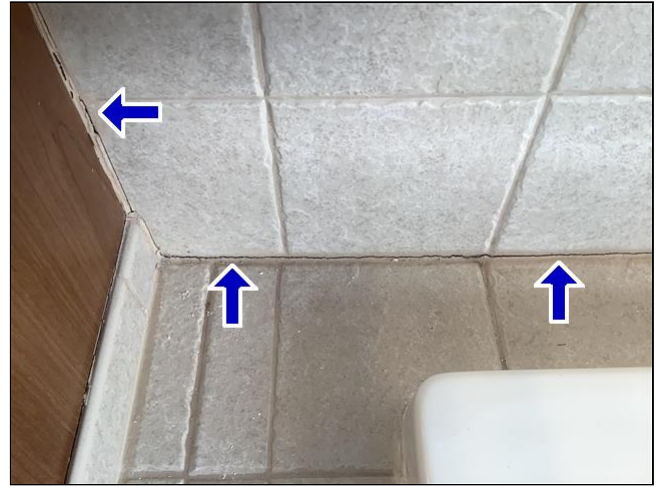
(1) The whirlpool tub operated properly, using normal operating controls, at the time of the inspection. However, gaps and cracks were noted around the whirlpool tub surround. This can allow moisture penetration and damage. Recommend repair.

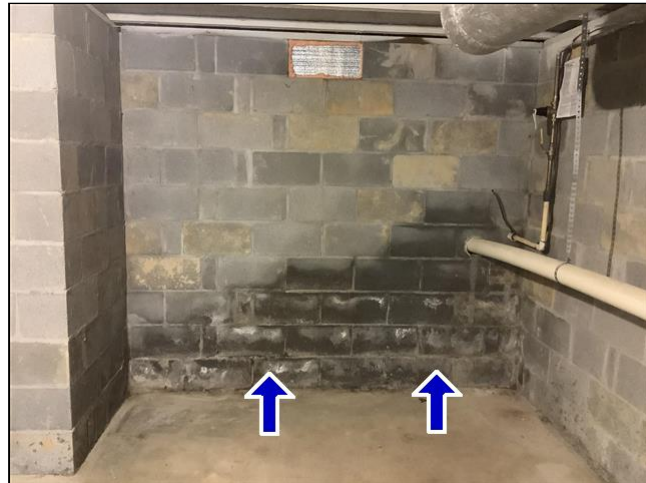
7.0 Item 1(Picture)

Evidence of water intrusion in the front foundation wall was observed. This is a common occurrence as masonry block is porous. No water was observed in the crawlspace itself. Recommend sealing the block with an approved sealant.

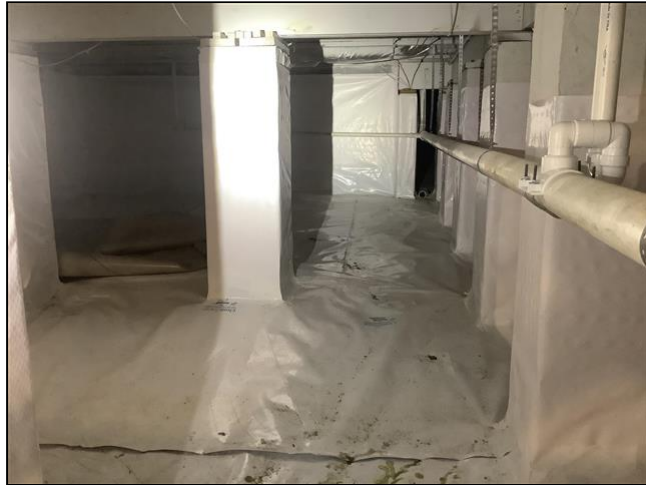
7.6 Item 1(Picture)

A moisture barrier was installed on all of the unfinished floor of the crawlspace.

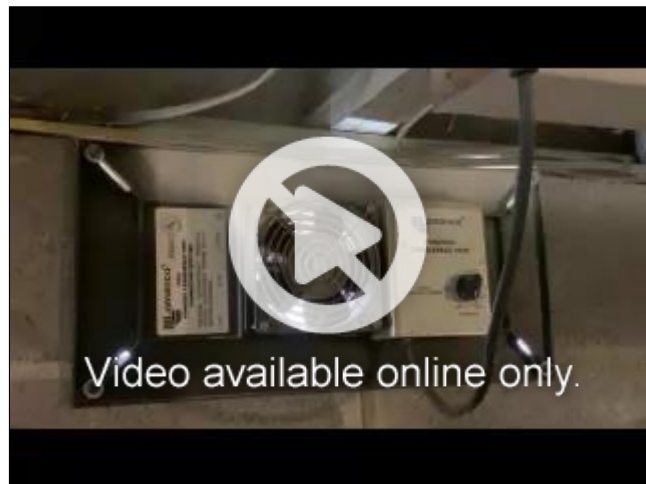
7.7 Item 1(Video)

The powered foundation vent fan operated properly, using normal operating controls, at the time of the inspection.

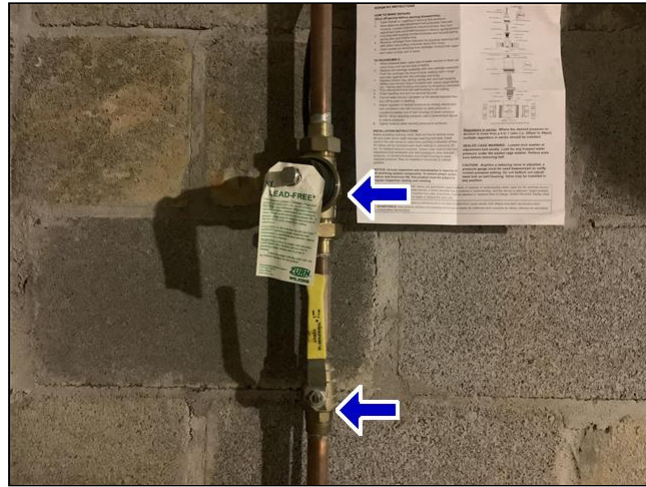
8.3 Item 1(Picture)

The main water shut-off and pressure reducing valve were in the basement near the front foundation wall.

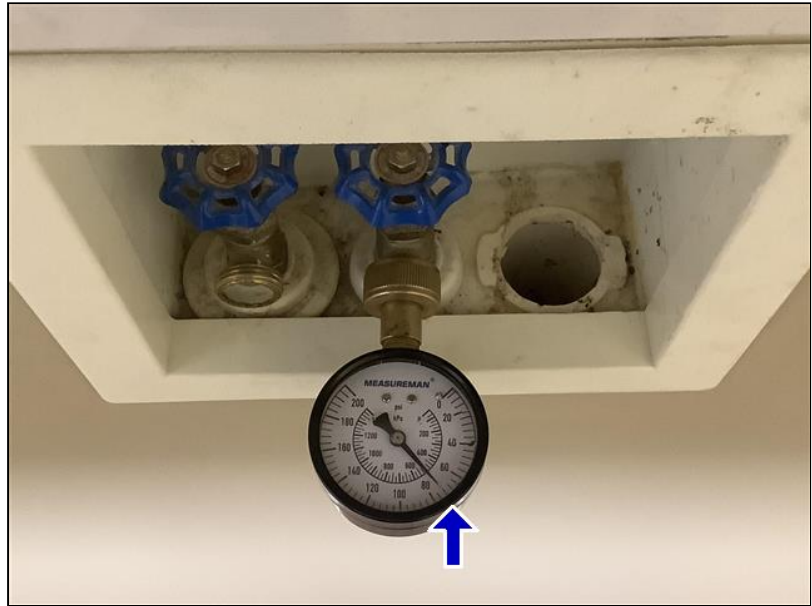
8.8 Item 1(Picture)

The standing water pressure was measured at 72 psi. The desired range is 40 - 80 psi.

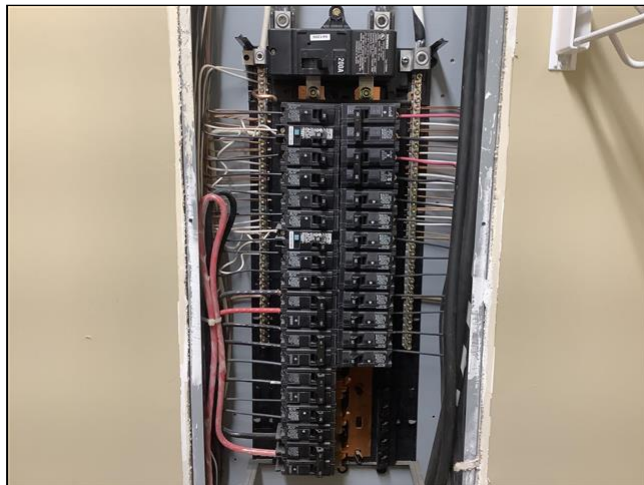
9.1 Item 1(Picture)

The panel is in the laundry room. No defects were noted.

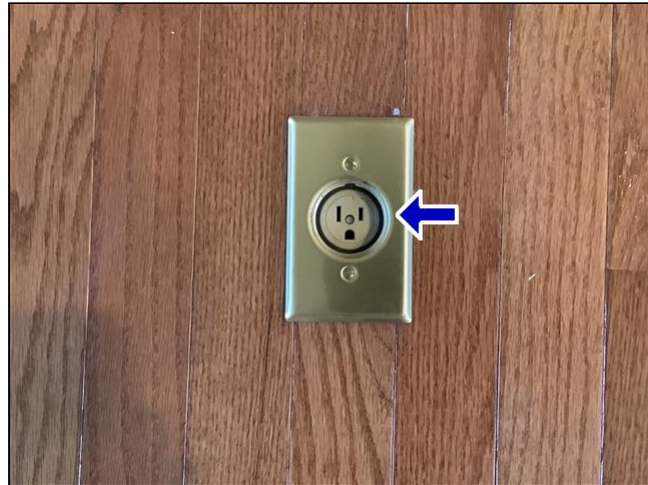
9.3 Item 1(Picture)

(1) This was an appropriate floor cover for this outlet, but it should have a cover when not in use. Recommend repair.

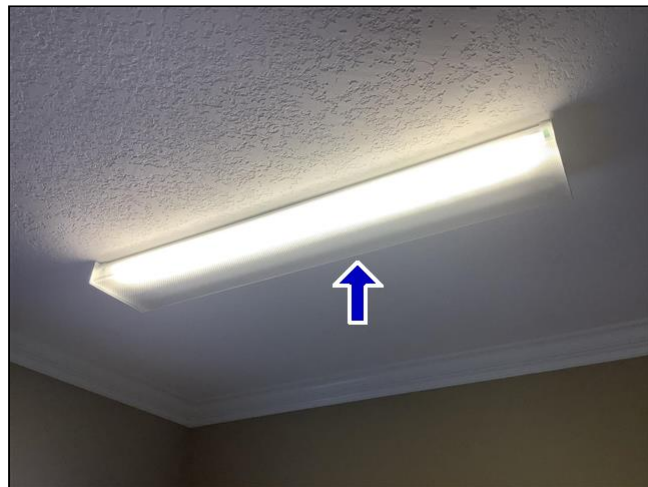
9.3 Item 2(Picture)

(2) A bulb was not working the master closet fixture. The bulb could have been burned out or there could have been a problem with the fixture. Recommend installing a new bulb and if it doesn't light up having the fixture further evaluated and repaired by a qualified tradesman.

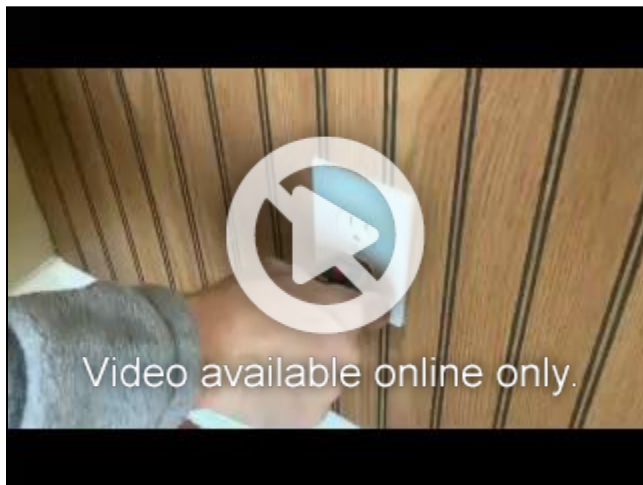
9.3 Item 3(Video) Kitchen

(3) Two loose outlets were noted. This is common and usually occurs because the outlet is not firmly screwed to the electrical box. Recommend repair by a qualified tradesman.

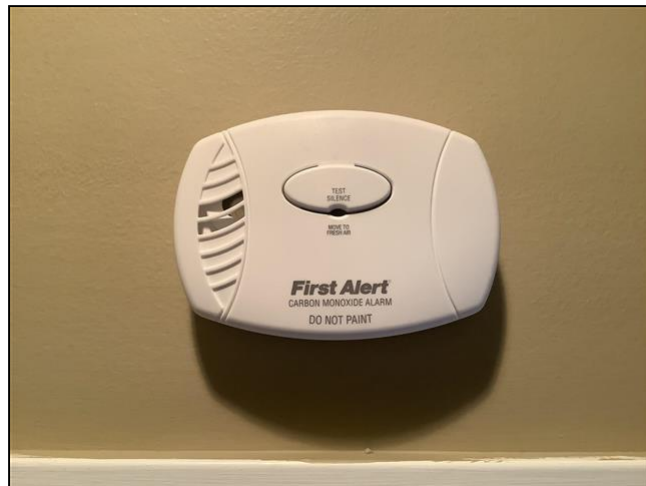
9.8 Item 1(Picture)

A carbon monoxide detector was found on the first floor in the hallway between the master bedroom and living room.

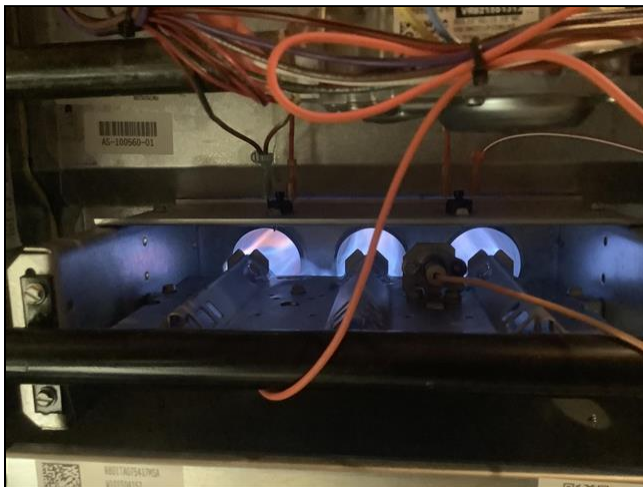
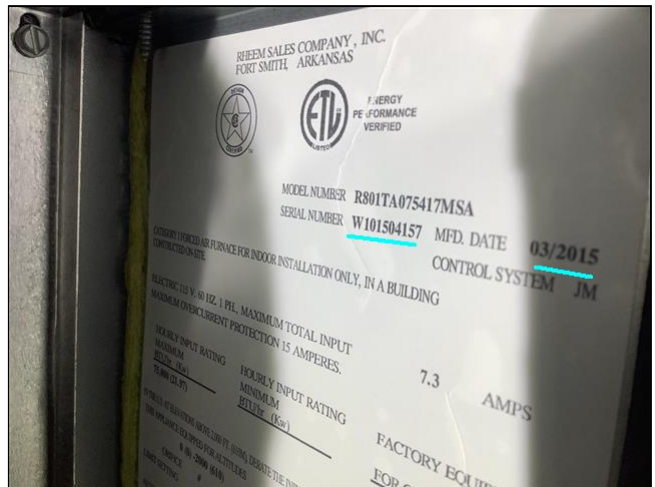
(1) The upstairs furnace was manufactured in 2015. The average life span of furnaces is 15 - 20 years, so this unit should have at least 10 - 15 years of serviceable life left. This information is not provided as a guarantee or promise of future performance, but is given to allow you to plan and anticipate future repairs.

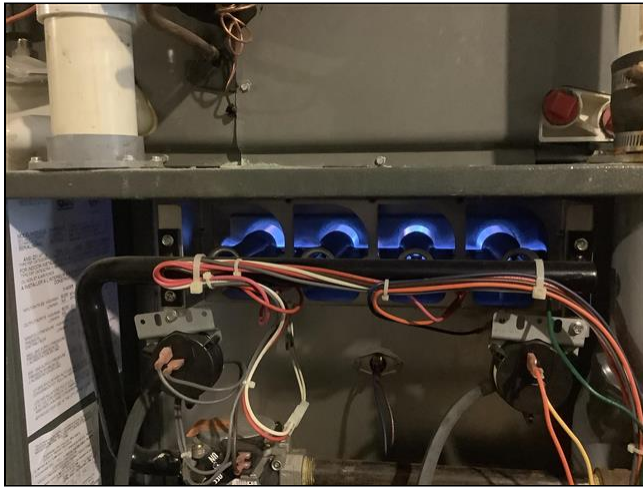
10.0 Item 3(Picture)

(2) The downstairs furnace was manufactured in 2005. The average life span of furnaces is 15 - 20 years, so this unit should have several years of serviceable life left. This information is not provided as a guarantee or promise of future performance, but is given to allow you to plan and anticipate future repairs.

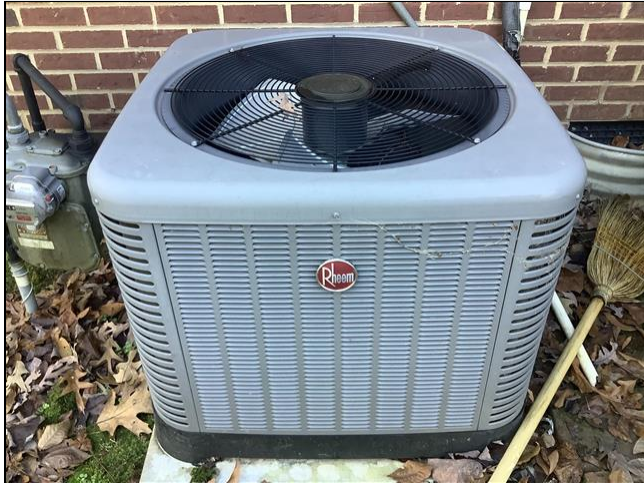
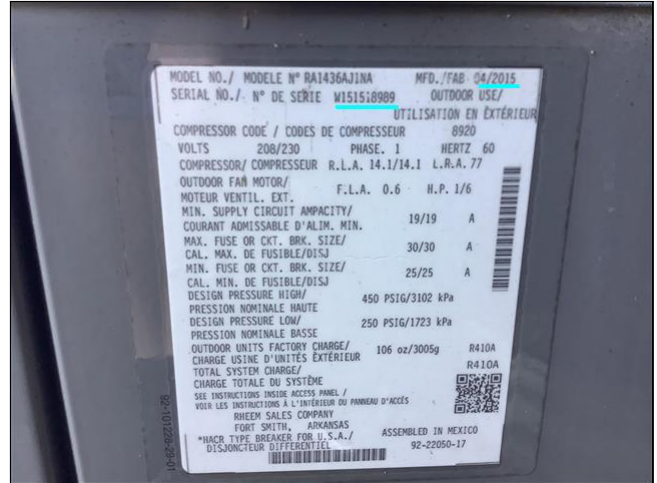
(1) The HVAC compressor for the upstairs unit was manufactured in 2015. The average life span of these components is 12 - 15 years, so this unit should have at least 7 -10 years of serviceable life left. This information is not provided as a guarantee or promise of future performance, but is given to allow you to plan and anticipate future repairs.

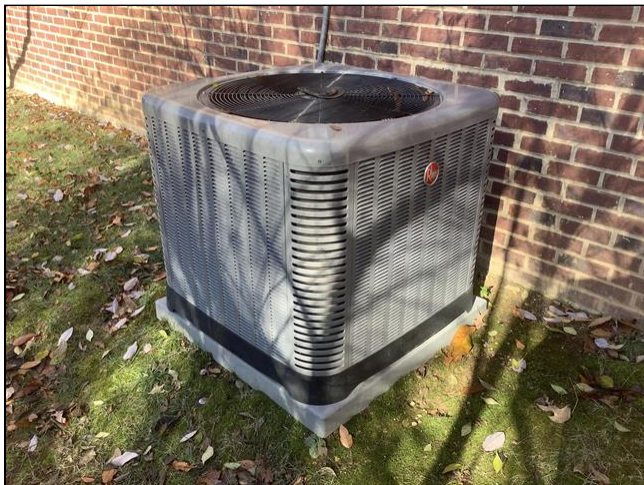
10.8 Item 3(Picture)

(2) The HVAC compressor for the downstairs unit was manufactured in 2016. The average life span of these components is 12 - 15 years, so this unit should have at least 8 -11 years of serviceable life left. This information is not provided as a guarantee or promise of future performance, but is given to allow you to plan and anticipate future repairs.

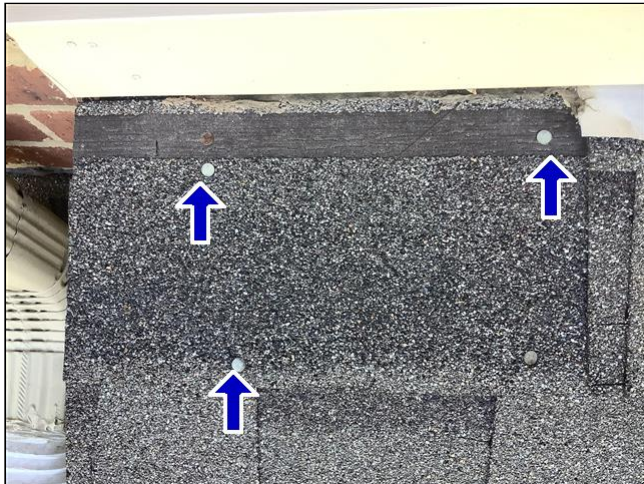
1.0 Item 2(Picture)

(2) Multiple exposed nail heads were found on the roof. All nail heads should be sealed to prevent rusting, which could lead to roof leaks. Recommend repair by a qualified tradesman.

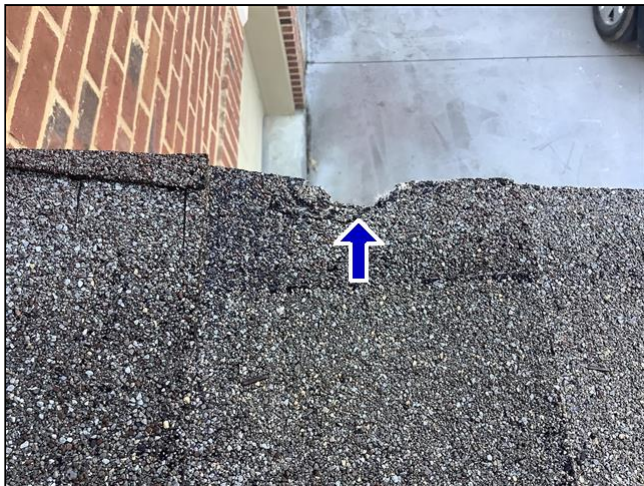
1.0 Item 7(Picture)

(3) Damage to shingles was noted in two places. These were on the edge of the roof, so the damage should not allow any leaks or damage to the structure itself.

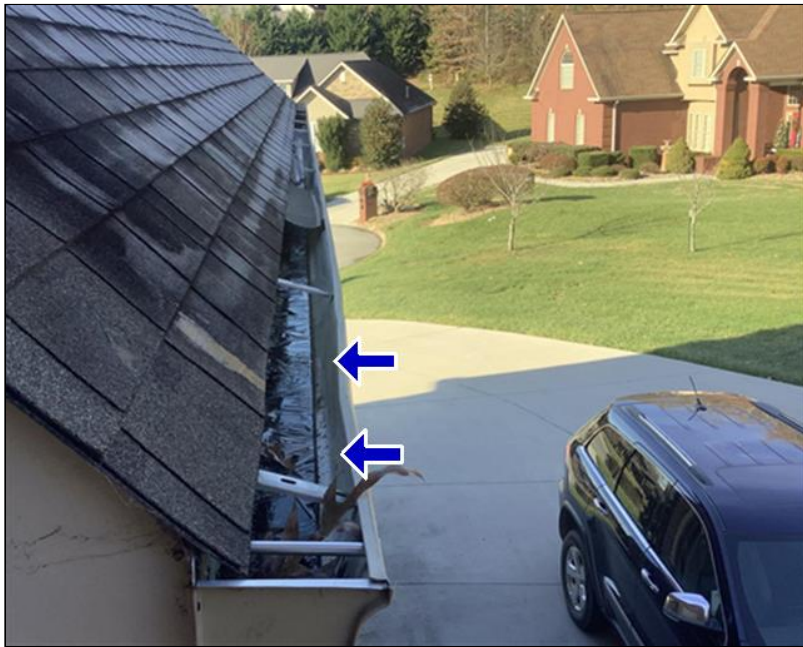
1.4 Item 1(Picture) Gutter over garage

(1) The gutter over the garage was holding water. Recommend evaluation and repair by a qualified tradesman.

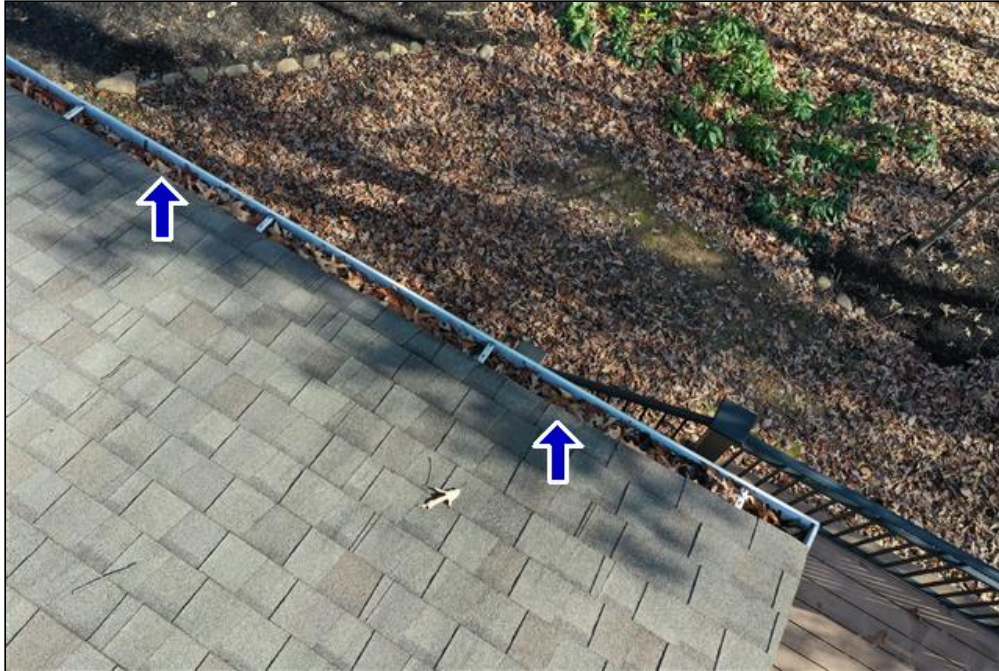
1.4 Item 2(Picture)

(2) The gutter for the sunroom was full of leaves. This can prevent water from draining properly. Recommend a full cleaning of the gutters.

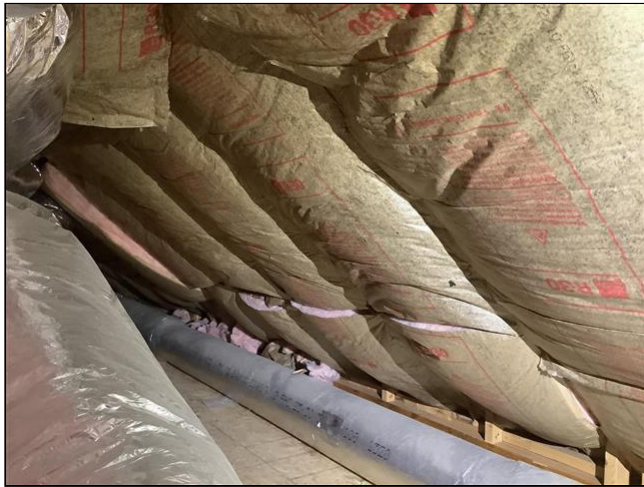
1.7 Item 1(Picture)

Insulation in the attic was installed with the vapor barrier exposed and on the interior. In Knoxville's climate, it is generally recommended that the vapor barrier be installed to the outside. Recommend further evaluation and repair by a qualified tradesman.

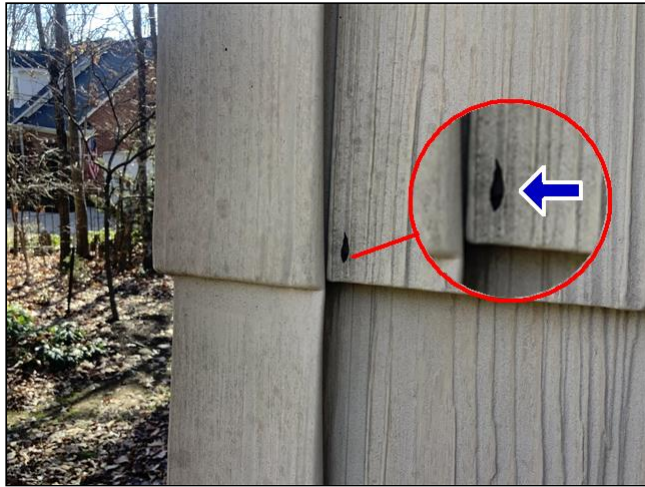
2.0 Item 1(Picture)

A penetration was noted in the vinyl siding on the sunroom. Recommend sealing to prevent water and pest intrusion.

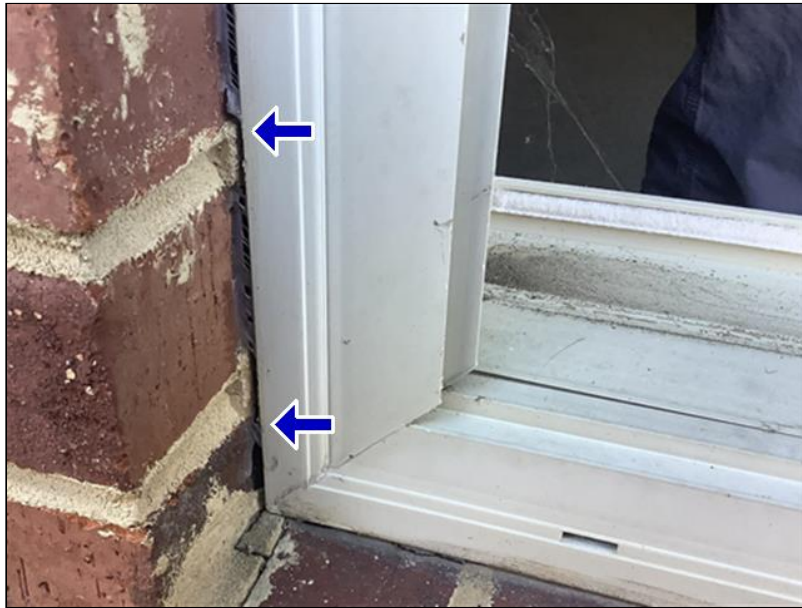
2.2 Item 1(Picture)

Gaps between windows and the brick cladding were noted at multiple windows. This is common and occurs as the installed sealant decays due to weather exposure. Recommend sealing to prevent water, air, and pest intrusion.

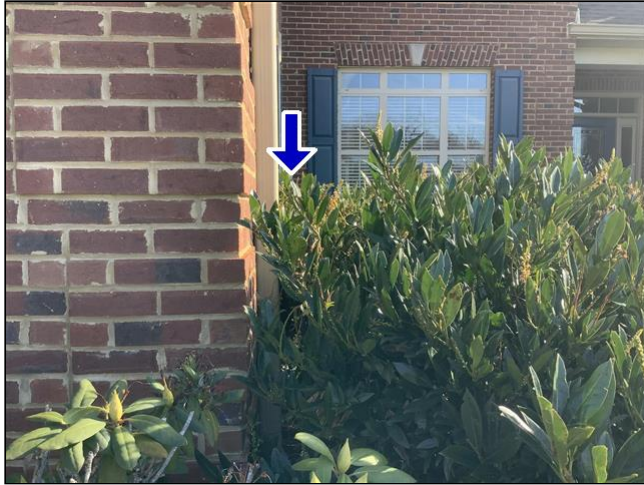
2.4 Item 1(Picture)

Vegetation was too close to the house. To prevent damage to the structure, recommend trimming all vegetation at least 12 inches away from the structure.

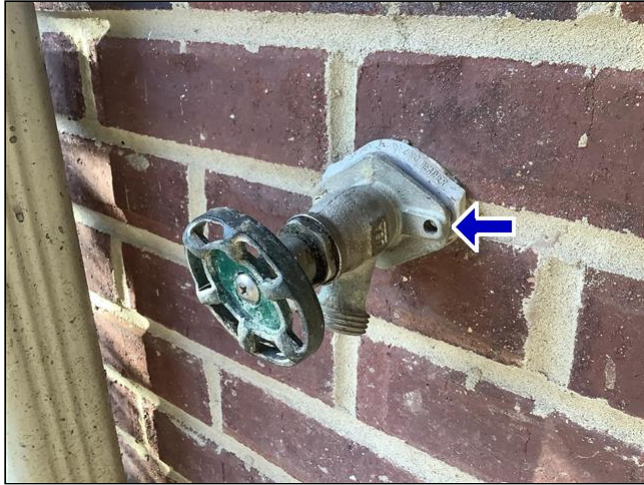
2.6 Item 1(Picture)

The hose bib was not properly attached to the structure at the time of the inspection. The bib should be fastened to the structure to prevent damage. Recommend repair.

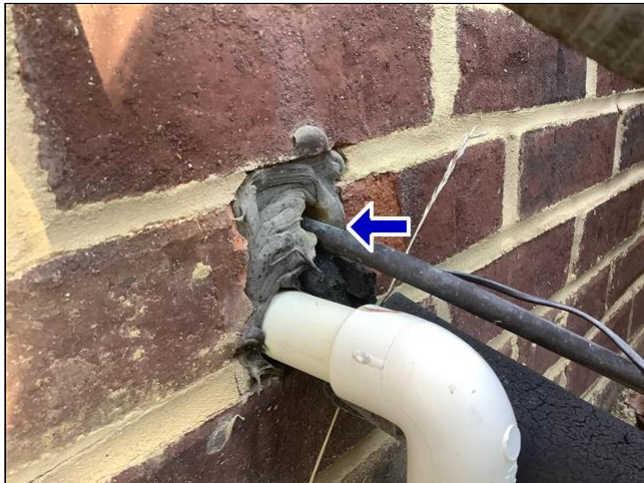
2.8 Item 1(Picture)

The penetrations for the downstairs HVAC lines were previously sealed and the sealant was decayed slightly. All exterior penetrations should be completely sealed to prevent water, air, and pest intrusion. Recommend repair.

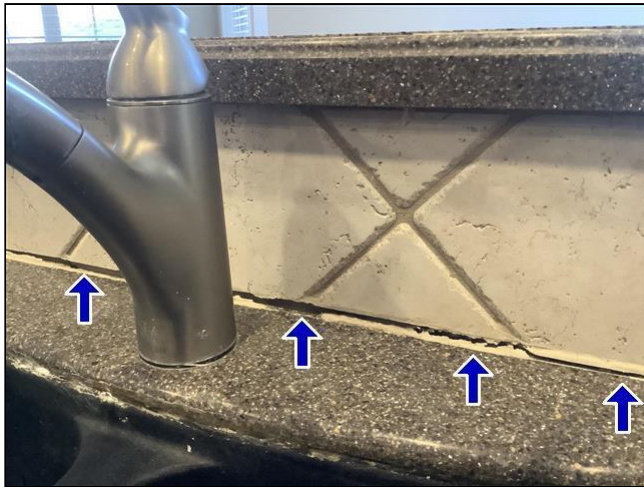
4.0 Item 1(Picture)

Gaps were noted between the countertops and adjacent walls. This can allow moisture penetration and damage. Recommend sealing.

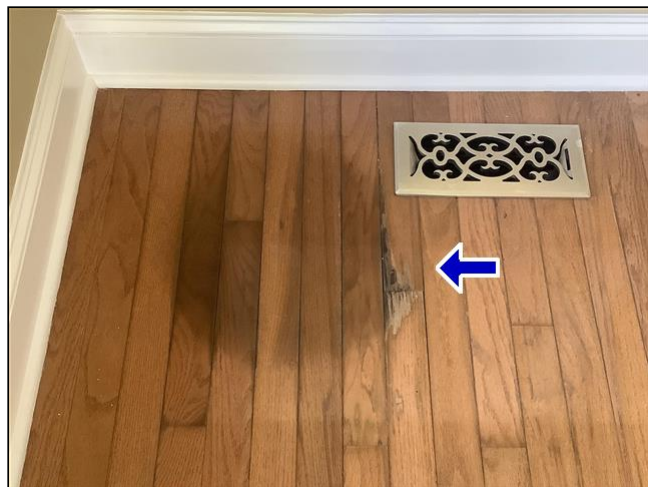
5.2 Item 1(Picture)

A water damaged area was noted on the floor near the kitchen. This was identified as a cosmetic defect and is noted for your information. Recommend repair.

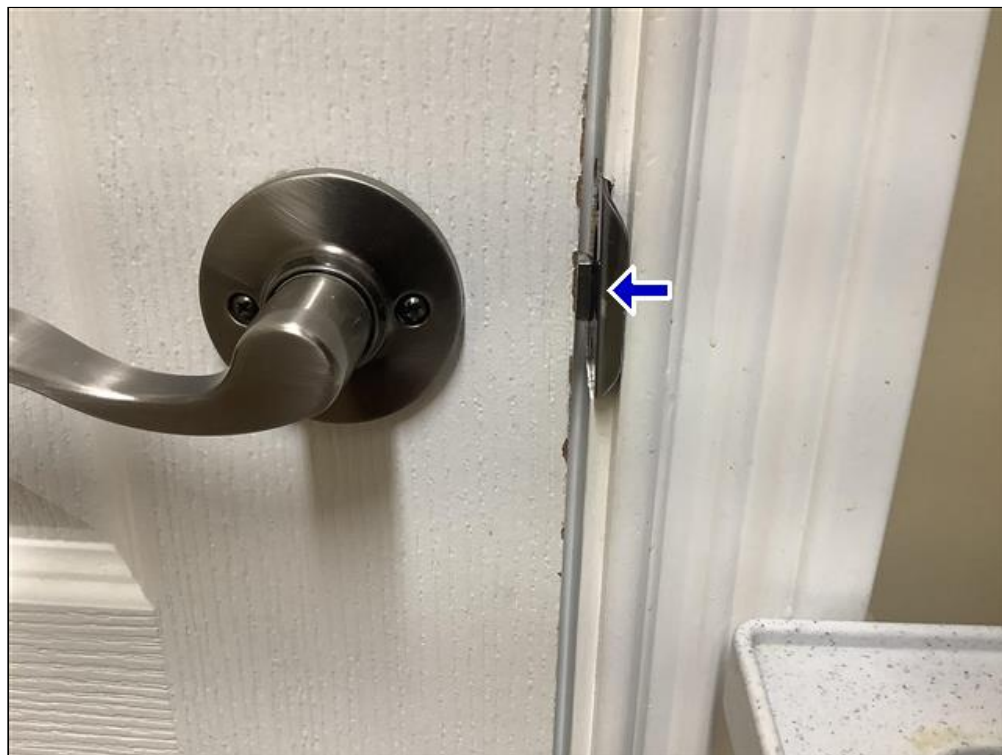
5.4 Item 1(Picture)

(1) The laundry room door did not latch when closed. Recommend further evaluation and repair by a qualified tradesman.

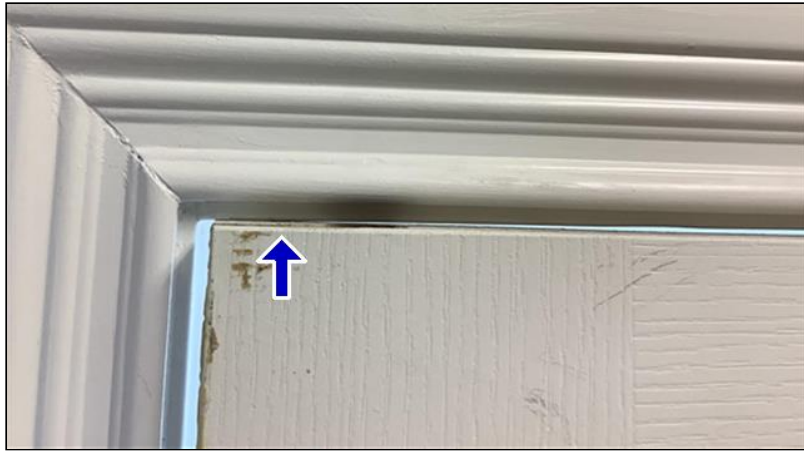
5.4 Item 2(Picture)

(2) The master closet door rubbed the door frame at the top. This did not allow the door to close completely. Recommend evaluation and repair by a qualified tradesman.

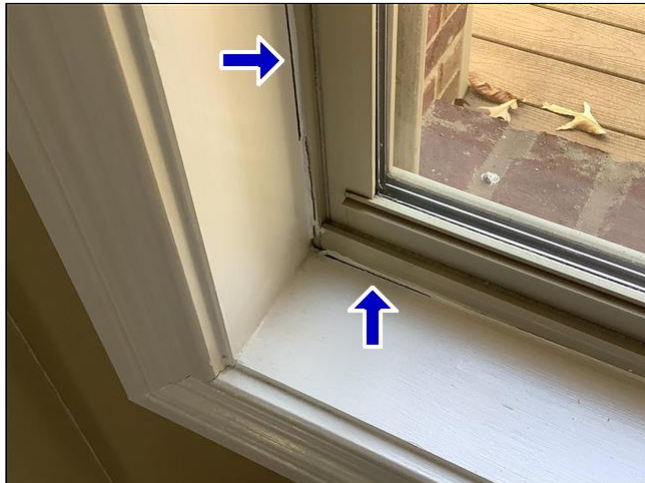
5.5 Item 1(Picture)

Multiple windows had gaps between the window sill and the window frame. This is a common occurrence and is usually caused by the expansion and contraction of the different materials (wood and vinyl). Recommend sealing all gaps around windows to prevent possible drafts.

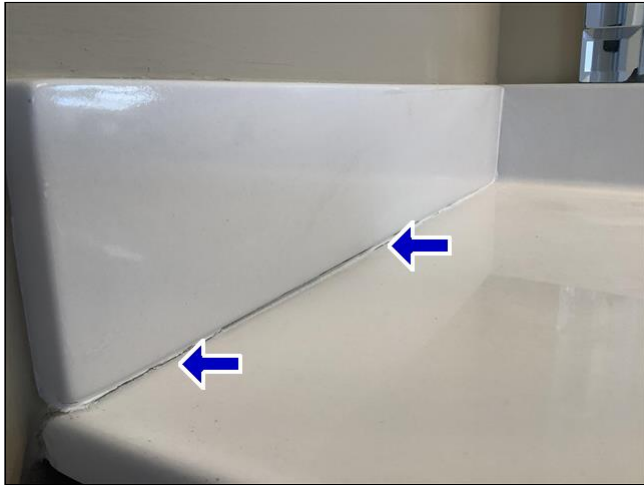
6.0 Item 1(Picture)

Gaps and cracks were noted around bathroom vanities. All gaps and cracks around sinks and other open water sources should be sealed to prevent water damage. Recommend sealing.

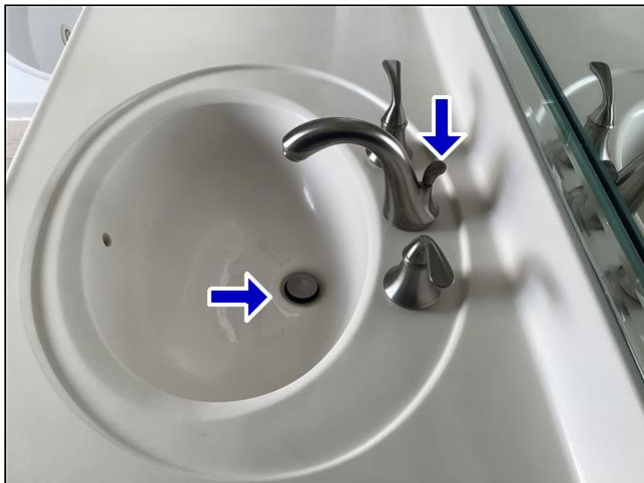
6.3 Item 1(Picture)

The right sink in the master bathroom did not have an operable drain stopper. Recommend further evaluation and repair by a qualified tradesman.

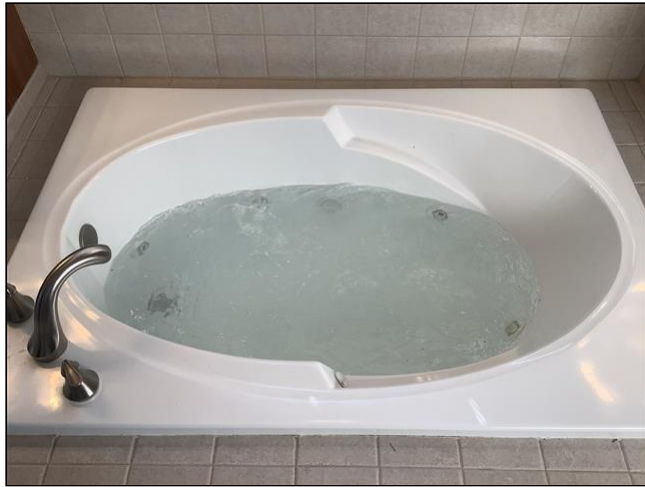
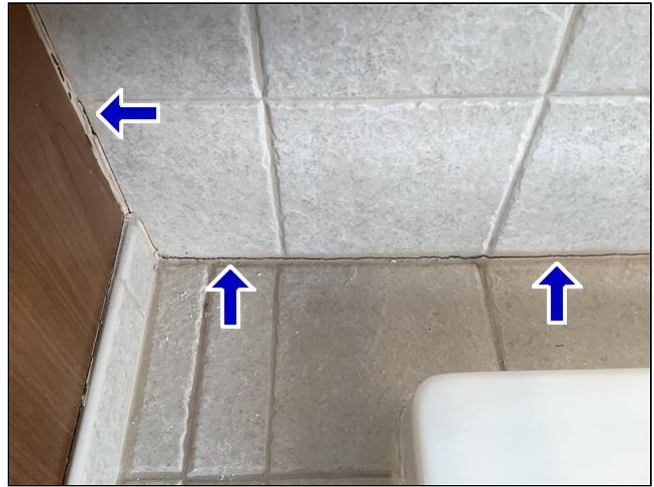
(1) The whirlpool tub operated properly, using normal operating controls, at the time of the inspection. However, gaps and cracks were noted around the whirlpool tub surround. This can allow moisture penetration and damage. Recommend repair.
