Inspection Report

Property Address:
123 Sample St.
Knoxville TN 37918

TnPro Residential Inspection, LLC

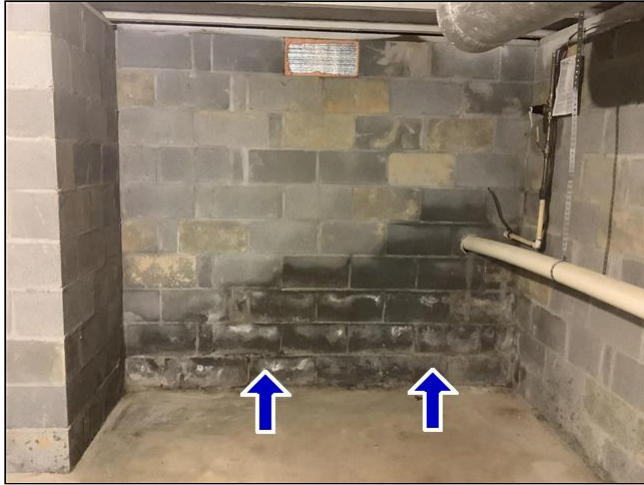
7.0 Item 1(Picture)

Evidence of water intrusion in the front foundation wall was observed. This is a common occurrence as masonry block is porous. No water was observed in the crawlspace itself. Recommend sealing the block with an approved sealant.

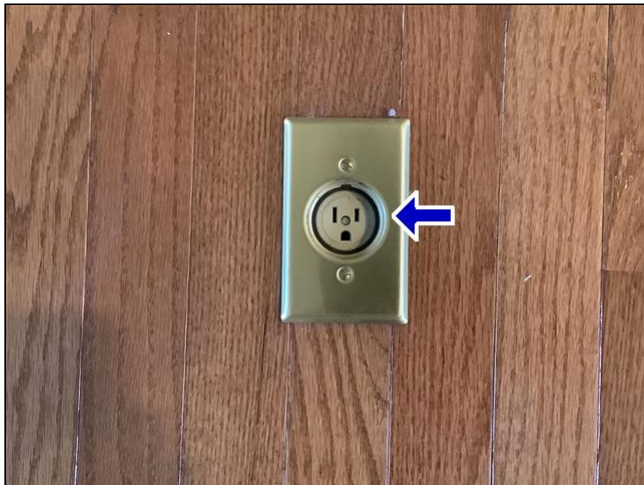
9.3 Item 1(Picture)

(1) This was an appropriate floor cover for this outlet, but it should have a cover when not in use. Recommend repair.

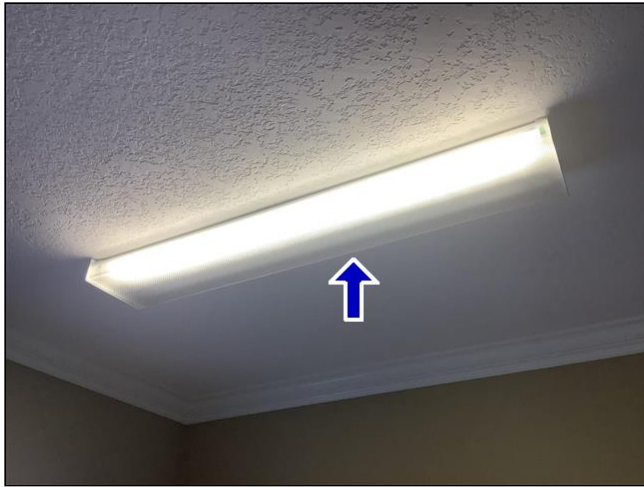
9.3 Item 2(Picture)

(2) A bulb was not working the master closet fixture. The bulb could have been burned out or there could have been a problem with the fixture. Recommend installing a new bulb and if it doesn't light up having the fixture further evaluated and repaired by a qualified tradesman.

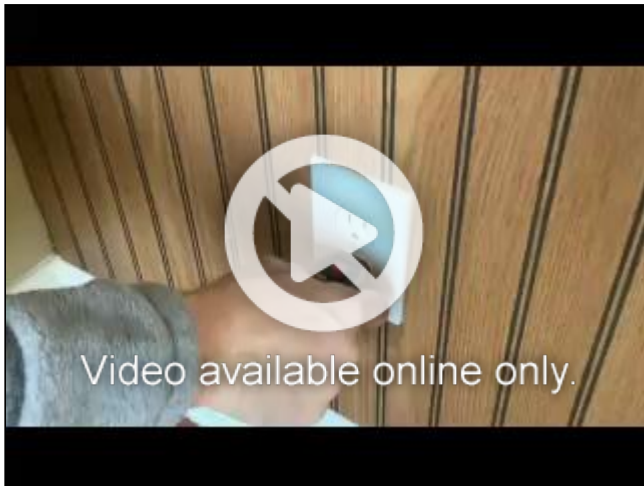
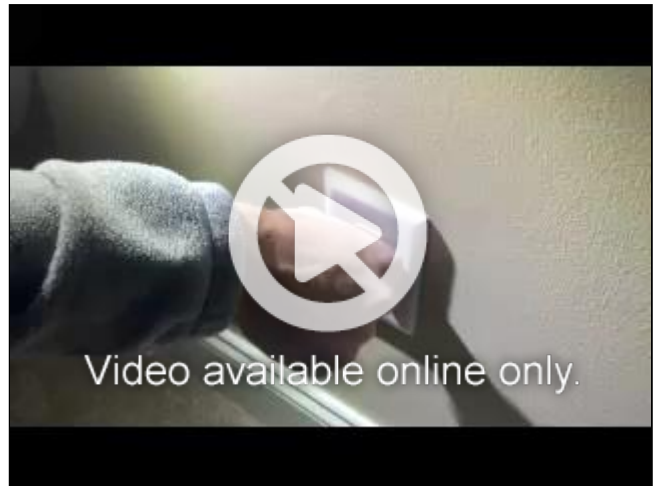
(3) Two loose outlets were noted. This is common and usually occurs because the outlet is not firmly screwed to the electrical box. Recommend repair by a qualified tradesman.
